## POR-15 Gastank Strip and Reliner Kit

by Moshe Levy

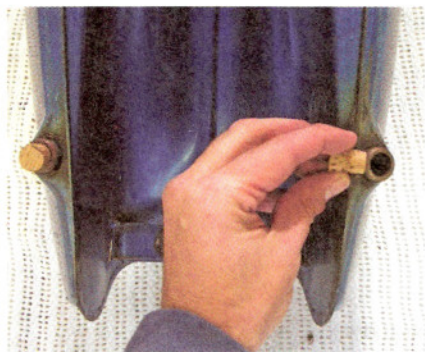
**Left:** Corks from the local hardware store are perfect for plugging the tank bungs. **Center:** Duct tape works well to seal the tank's filler hole. **Right:** Use a heat gun to *completely* dry the tank prior to application of the final sealer—this is critical.

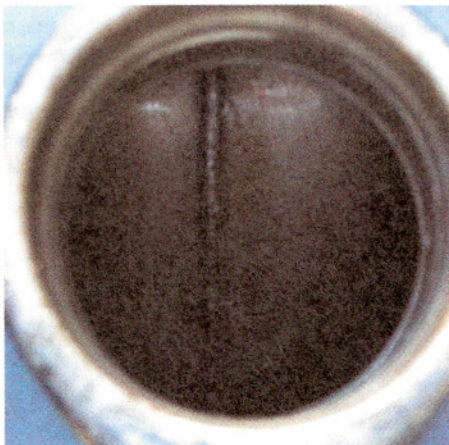
**Gastank after:** Properly applied; even coverage on all interior surfaces of the tank.

Once the tank came back from Saucier's shop, I peered inside with a high-powered flashlight, and was delighted to see the smooth, uniform, spotless coverage of the gray-colored POR-15 tank sealer on every surface in sight. Figure 6 is a close-up of the filler hole, showing the visible coverage.
